Initial Assessment for Spring 2007 Pulse Flow Implementation

Potential Associated Costs and Good Neighbor Impacts

Appendix E. Site visits at diversion structures in the North Platte and Platte River systems.

Site Visit at Diversions along the North Platte River System September 26, 2006

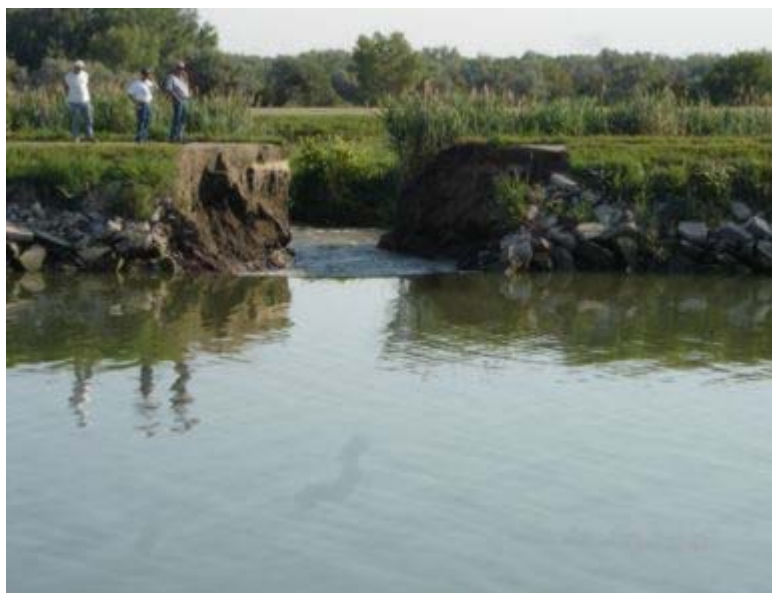
Central personnel evaluate the canal break

In the meantime, Ostergard had discovered the source of the water: a 20-foot-wide

break in the Supply Canal's bank located about 1.5 miles downstream from the Diversion Dam. At the time, flows in the canal measured about 1,800 cubic feet per second, about 70 percent of its capacity. Water was spilling through the breach in the bank into an alfalfa field and then flowing into a sandpit lake located near the river. Unable to hold the inflows, the small sandpit spilled the overflow into a nearby drainage ditch that drains to the Platte River.

Whether the break occurred gradually or suddenly is not known, but the suspected cause of the break is burrowing by muskrats or other animals, creating a condition referred to as "piping." The burrows create cavities in the bank that can expand and weaken the earthen banks. Under the right circumstances, the piping can lead to bank failure.

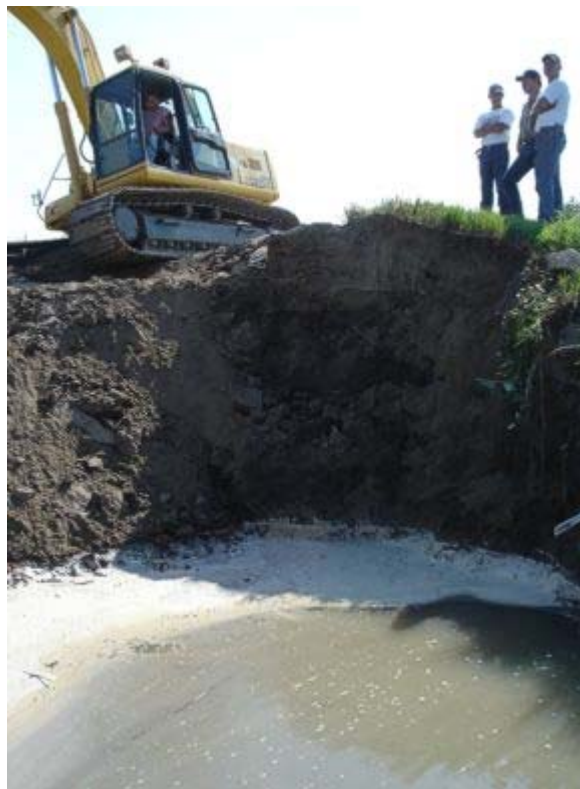
Repair work in progress

The excavator arrived at 10 a.m. and was quickly put into service placing the first of about 400 cubic yards of dirt in the breach. By noon, excavator operator Doug Max had closed the breach and compacted the fill. Max then began placing 50 cubic yards of concrete riprap to protect the repaired canal bank. By 1:00 p.m., the break had been sufficiently reinforced to allow Central to close the Diversion Dam's river gates and re-open the headgates of the Supply Canal to allow water to begin refilling the affected section of canal.

While the breach was being repaired, Viter directed Heavy Equipment Operator Lonnie Warner to begin cutting steel sheet piling into sections for use at the repair site. Forty-five linear feet of sheet piling were transported to the site and driven into the repaired section by 2 p.m. By that time, normal canal diversions and water conveyance had resumed.

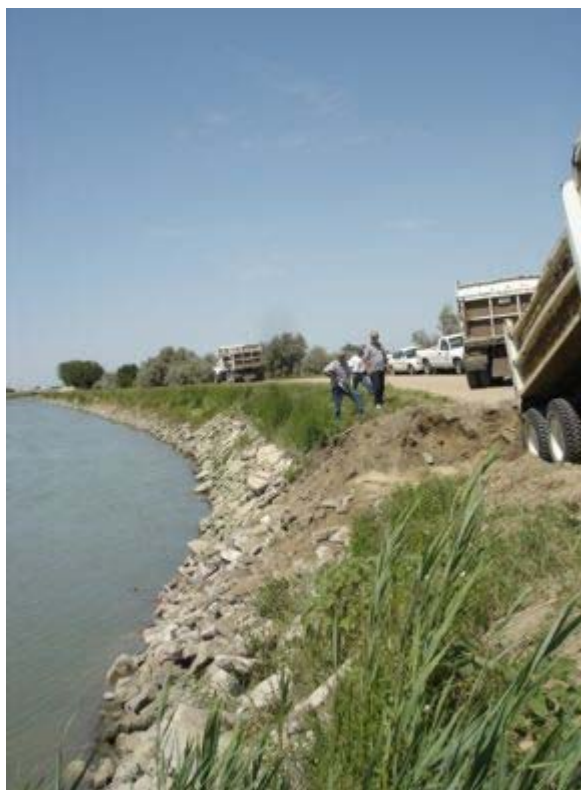
Repair work near completion

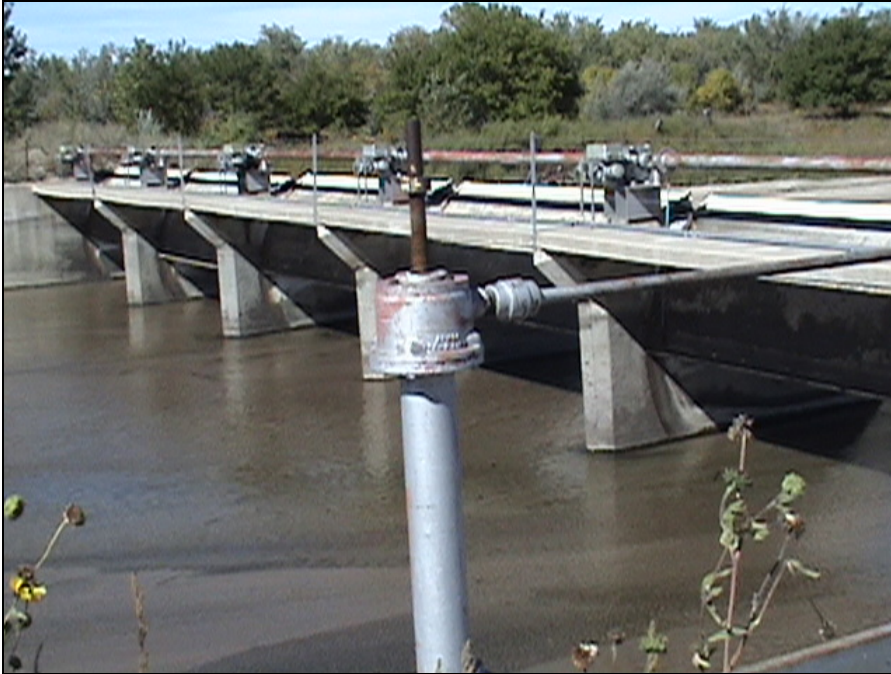
- Representative Doug Marquette
- Priority date 2-2-1894 (81 cfs)
- No debris concerns because diversion is first in line and receives the highest flow (@ 1,400 cfs last year)

Figure 1. Diversion for Keith-Lincoln Canal.

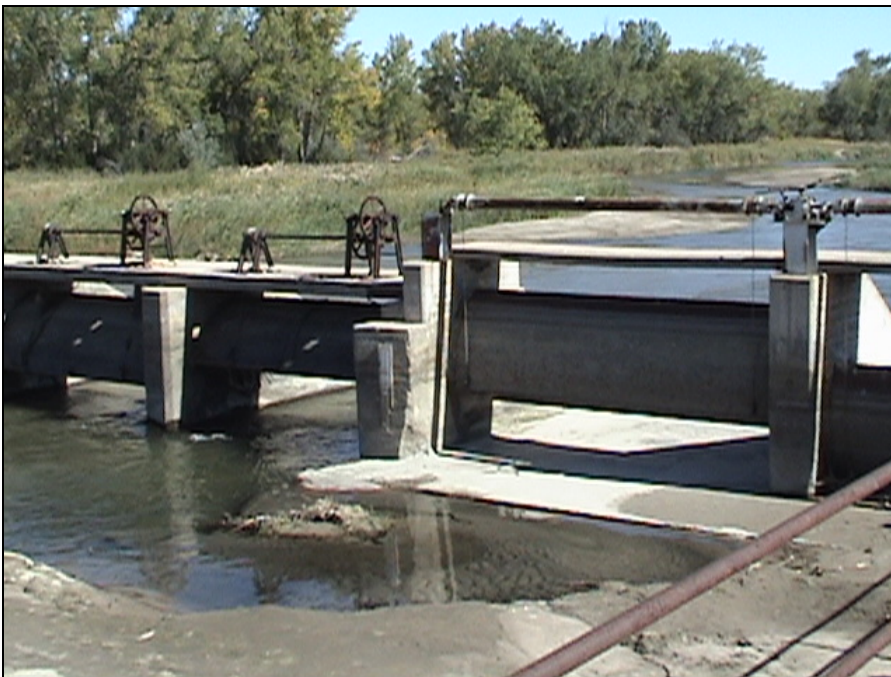
- Representative Martin Fisher
- Priority date 5-13-1884 (201 cfs)
- There is also a concern for debris build-up especially if flows are to exceed recent high flows (i.e., approximately 1,400 cfs minus Keith-Lincoln canal diversion)

Figure 2. Diversion for Platte Valley Canal.

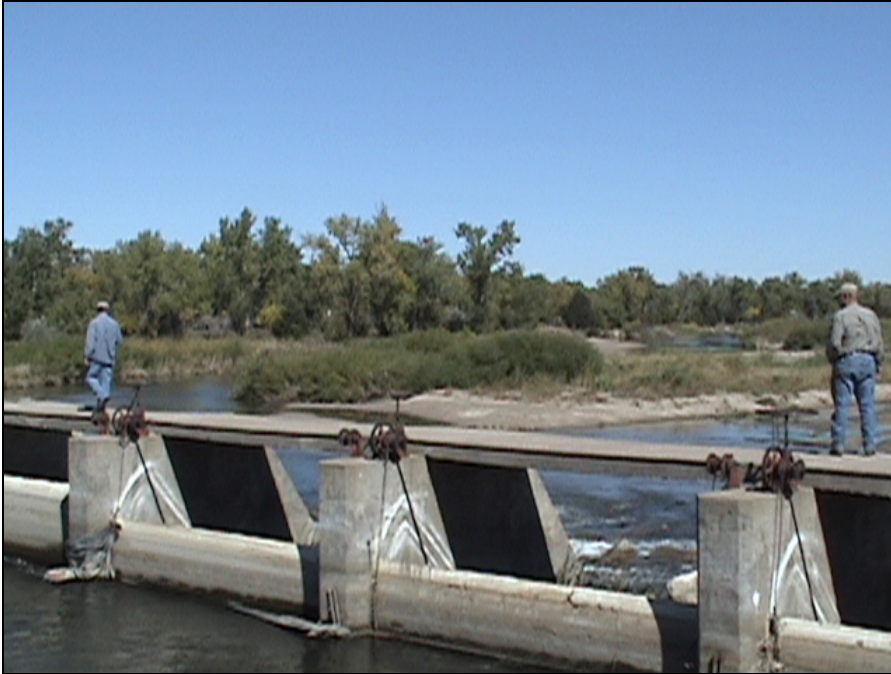
Figure 3. Diversion for Paxton-Hershey Canal (South End).

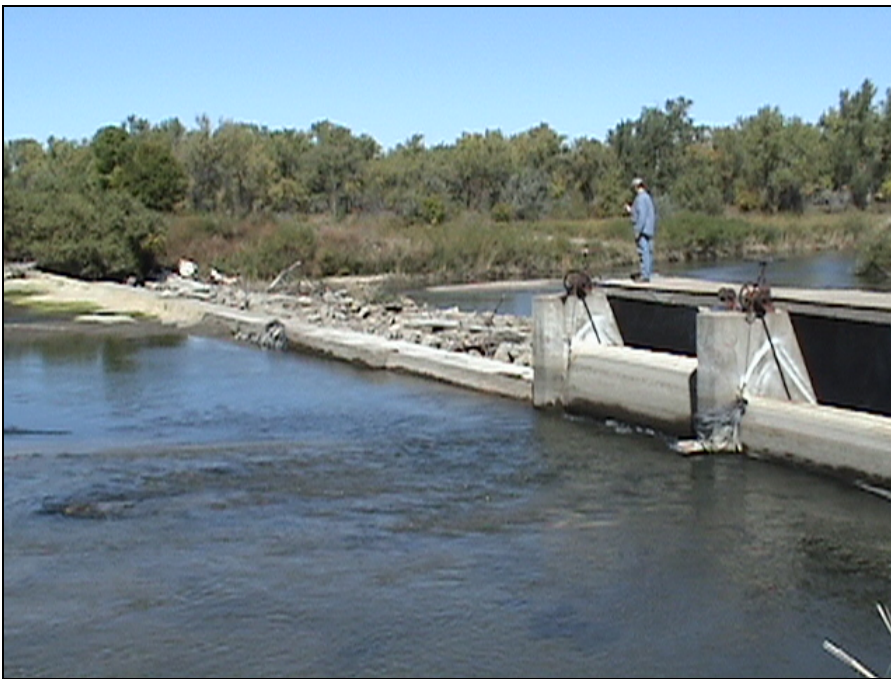
- Representative Earnest Schuster
- Priority date 2-12-1894 (103 cfs)
- Since Suburban Canal receives much of their water from Birdwood Creek, very little flow passes the Paxton-Hershey Canal diversion for much of the irrigation season
- There is concern for debris build-up especially if flows are to exceed recent high flows (i.e., approximately 1,400 cfs minus Keith-Lincoln and North Platte canal diversions)

Figure 4. Diversion for Paxton-Hershey Canal (North End).

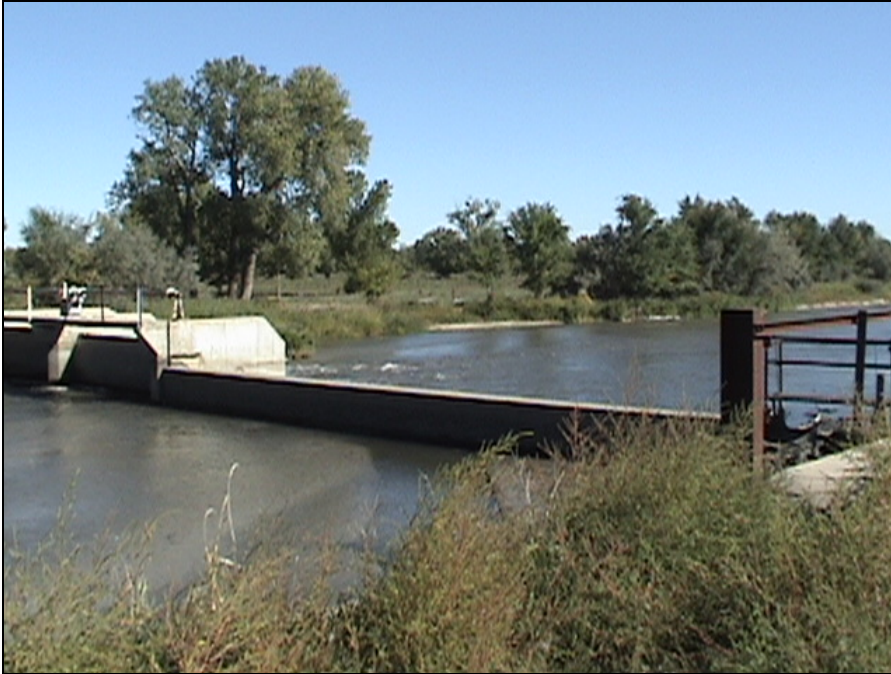
Figure 5. Diversion for Suburban Canal.

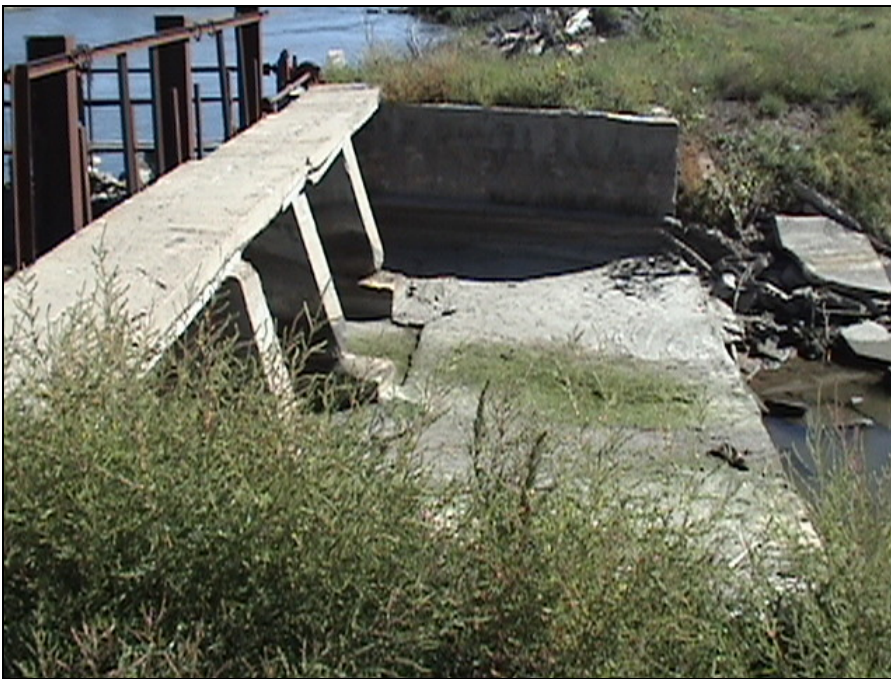
- Representative Martin Fisher for Lloyd Bauer
- Priority date 5-22-1894 (78 cfs)
- Canal has 2 diversions located on 2 separate channels
- Can shift flows from one diversion to other if trash build-up is observed
- Receives consistent base flows from Birdwood Creek (a consistent, spring-fed tributary to the North Platte River)

Figure 6. Gates for Suburban Canal.

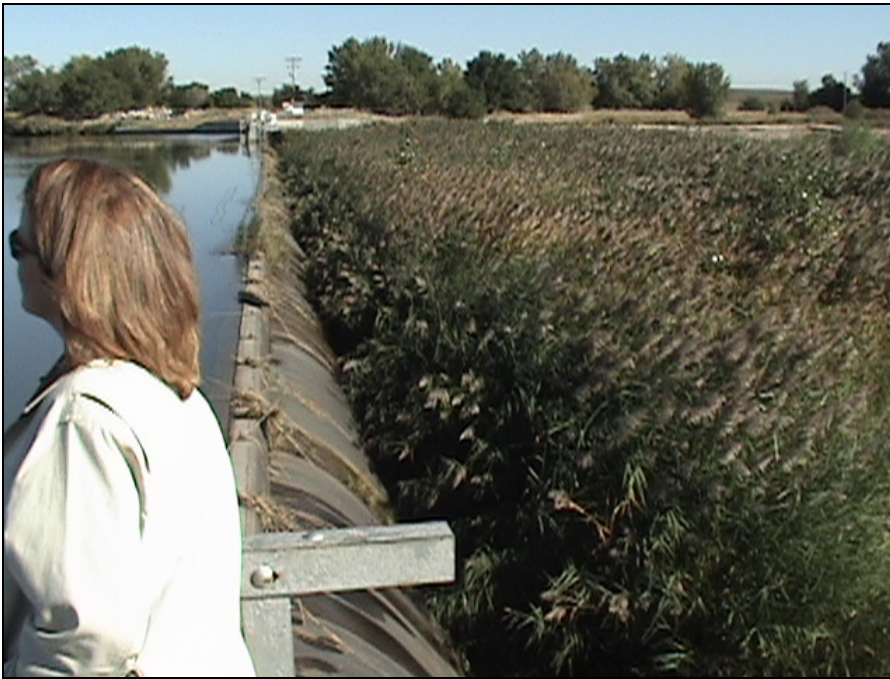
- Representative Kevin Boyd
- 5 low flow gates (Figure 7 and 8) can pass 1,500 cfs
- opening remaining 8 gates (all gates open, Figure 8) would allow 26,000 cfs to pass which diminishes likelihood of trash accumulation

Figure 7. Tri-County Diversion Dam (Low Flow Area – North Side).

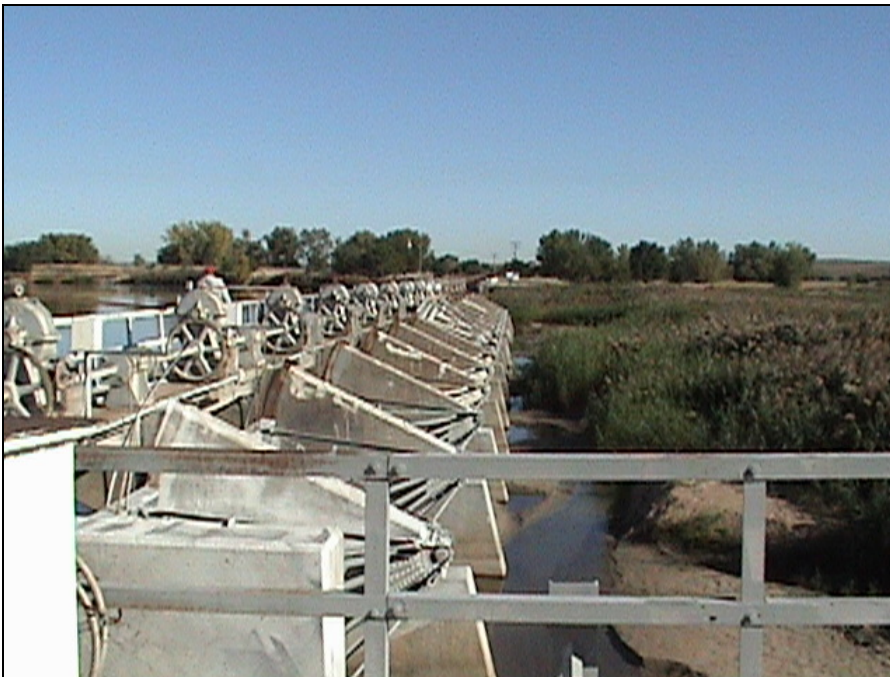
Figure 8. Tri-County Diversion Dam (Full View).

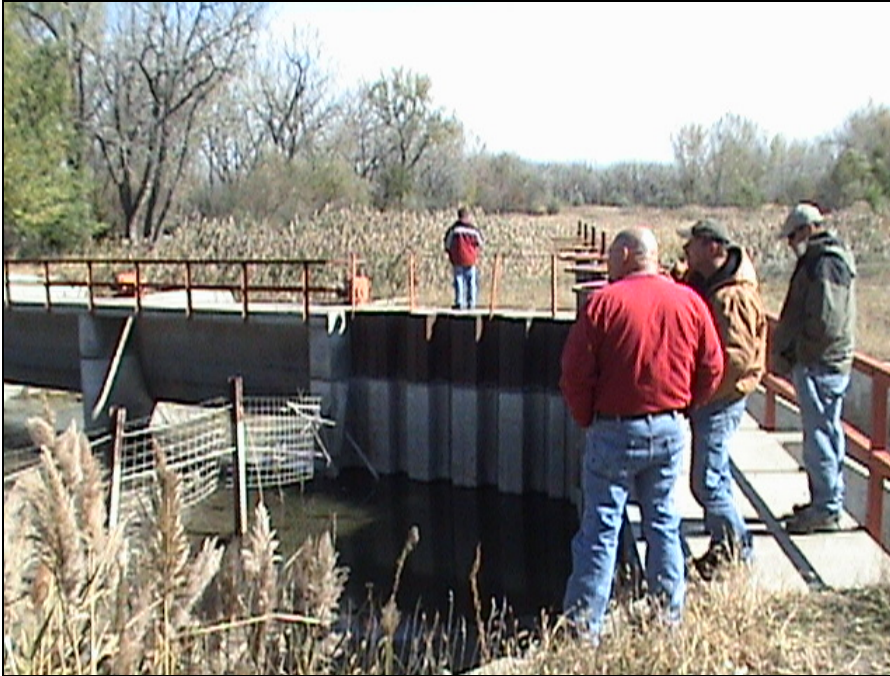
- Representative Jim Harris
- Priority dates 10-22-1894 to 12-13-1927 (total 303 cfs)
- Solidly built mainstem diversion that receives water primarily from the Jeffrey Hydro return
- Water that bypasses the diversion flows through the north channel past the Gothenburg Canal diversion
- Water is allowed to flow through phragmites-choked south channel after the irrigation season (Figure 10)
- One sand dam located between the 30-mile and Gothenburg Canal blocks an overflow channel (Figure 11)
 - Sand dam was last breached in by high flows in approximately 1997 (approximately 15,000 cfs)

Figure 9. Main channel diversion for the 30-mile Canal.

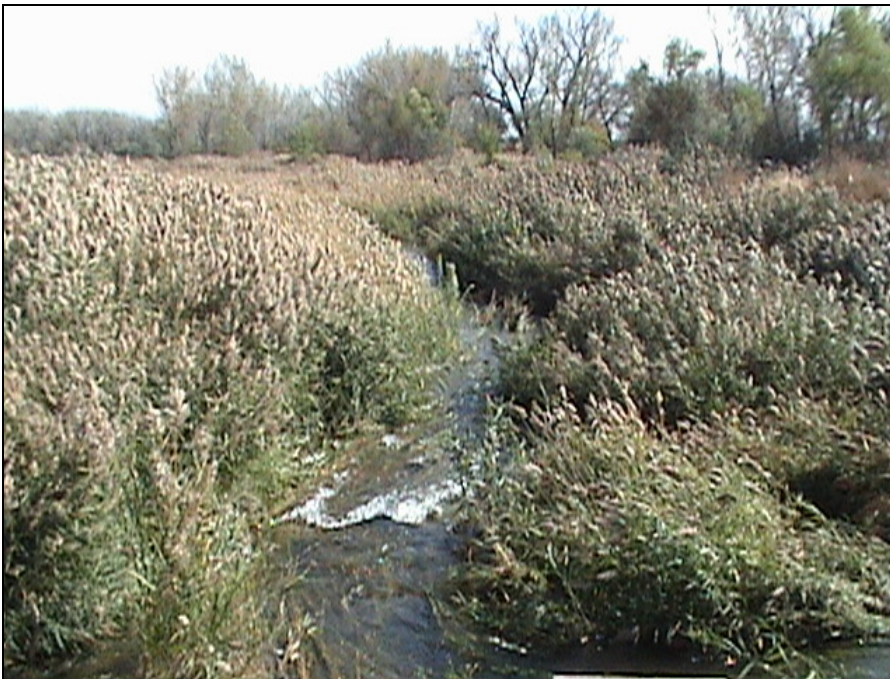
Figure 10. South channel of Platte River downstream of the 30-mile Canal diversion.

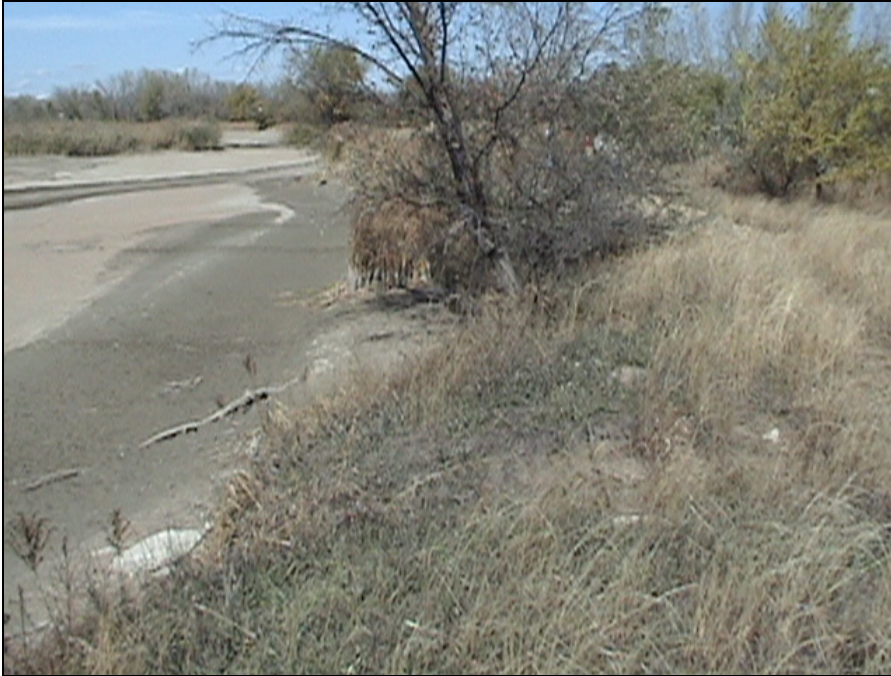
Figure 11. Sand dam blocking overflow channel between 30-mile Canal and Gothenburg Canal diversions.

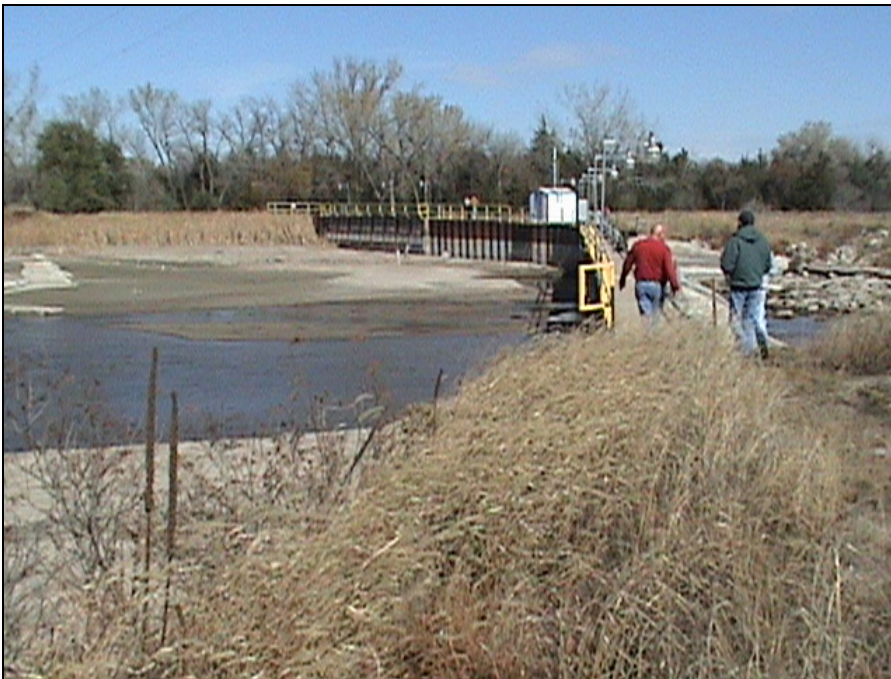
- Representatives Dave Webster and John Shadle
- Priority dates 7-5-1890 to 7-23-1990 (total 272 cfs)
- Solidly built mainstem diversion that receives water from the 30-mile canal bypass and the Platte River (nearest gage at Brady) (Figure 13)
- Water that bypasses the diversion flows through the north channel past the Gothenburg Canal diversion
- Bypassed water provides flows to remaining canals along the Platte

Figure 12. Main channel diversion for the Gothenburg Canal.

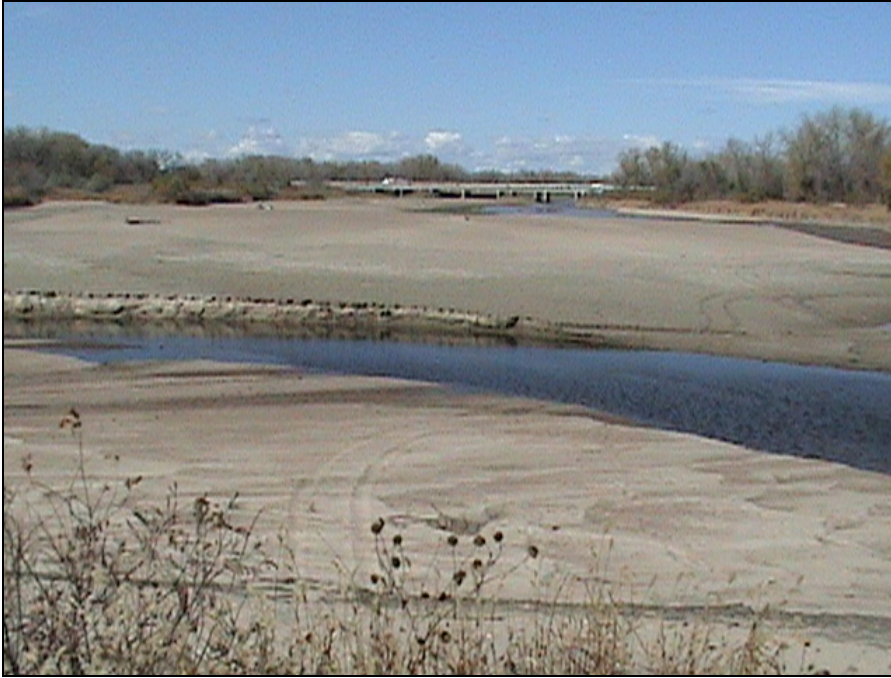
Figure 13. Platte River upstream of Gothenburg Canal diversion (Brady Bridge in view).

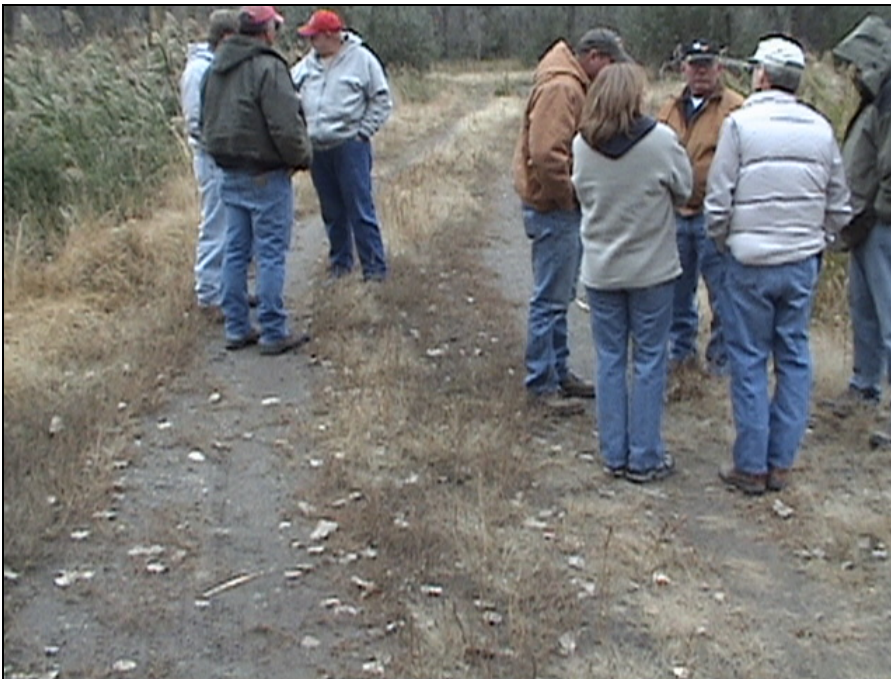
- Flows from the Gothenburg Canal bypass has a tendency to migrate from the north channel to the south channel
- Sand dam was created to divert the majority of flows to the north channel
- Two 24" culverts in sand dam allows for a minimum flow to reach diversions along the south channel (Figure 15)
- Sand dam was breached in mid-1990s has not been breached since

- Phragmites encroaching in channel above the dam creating possible water supply problems to south channel diversions
- Decreasing availability of sand in channel increases difficulty in rebuilding sand dams

Figure 14. Platte River Sand Dam.

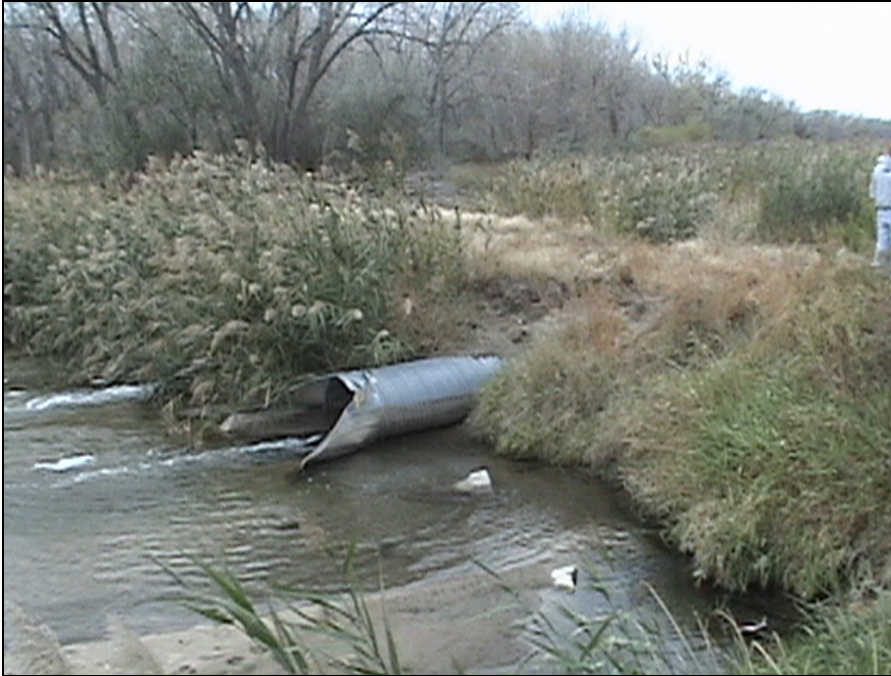
Figure 15. Culverts in the Platte River Sand Dam.

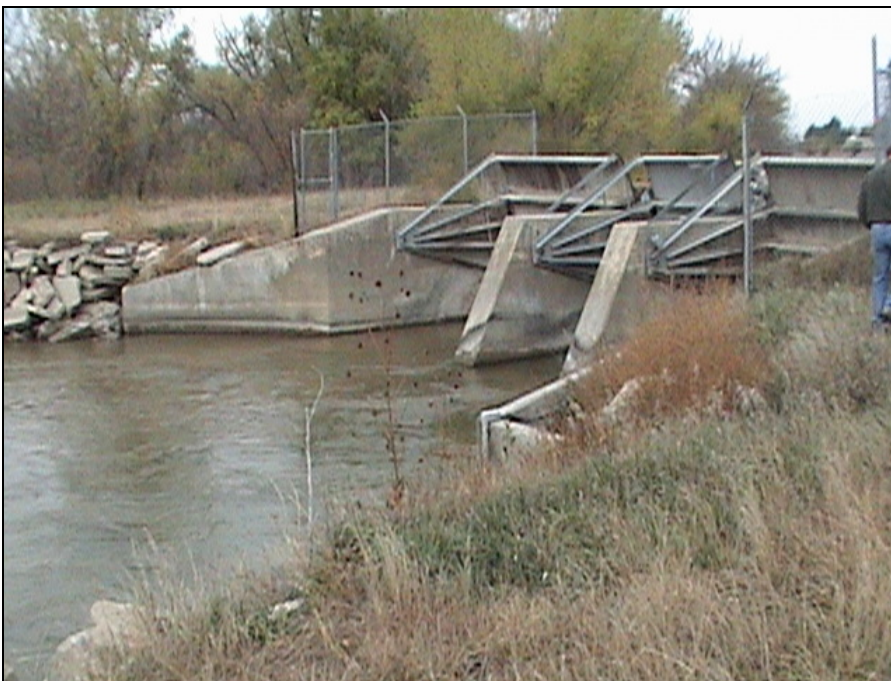
- Representative Les Wolf (Figure 16)
- Priority dates 12-28-1894 to 7-23-1990 (total 235 cfs)
- Located on northern channel below Platte River Sand Dam
- Two additional sand dams needed to force water to diversion
 - One dam built with rock and trees prevents water from flowing onto a KOA campground located on south side of I-80 interchange
 - Sand dam was not washed out for duration of Les's appointment as canal manager (2001 to present)
 - Les has no knowledge of prior breaches
 - A second sand dam is needed to keep water from flowing around the diversion through a side channel
 - Sand dam was breached in 2004 (peak flows of 1,226 cfs at Brady/Jeffrey and 253 cfs at Cozad)
- Solidly built diversion with stabilized streambanks
- Bypassed water provides flows to Dawson Canal

Figure 16. Main channel diversion for the Cozad Canal.

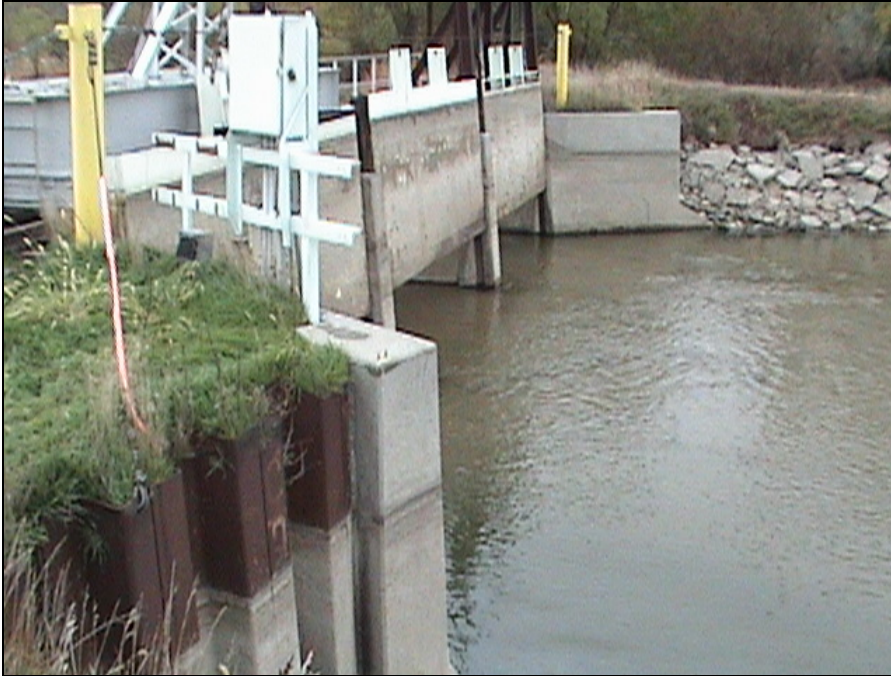
Figure 17. Main channel diversion for the Dawson Canal.

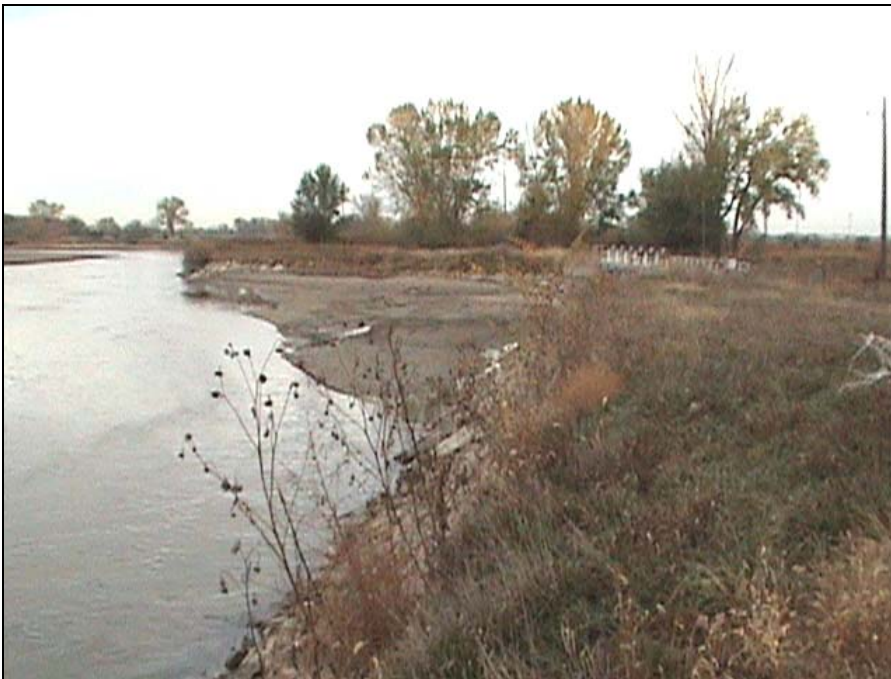
- Representatives Dave Webster and John Shadle
- Priority dates 6-14-1984 to 6-28-1979 (total 449 cfs)
- Located on northern channel below Cozad Canal Diversion
- Solidly built mainstem diversion with stabilized streambanks (Figure 18)

Figure 18. Regulating dam for the Dawson Canal.

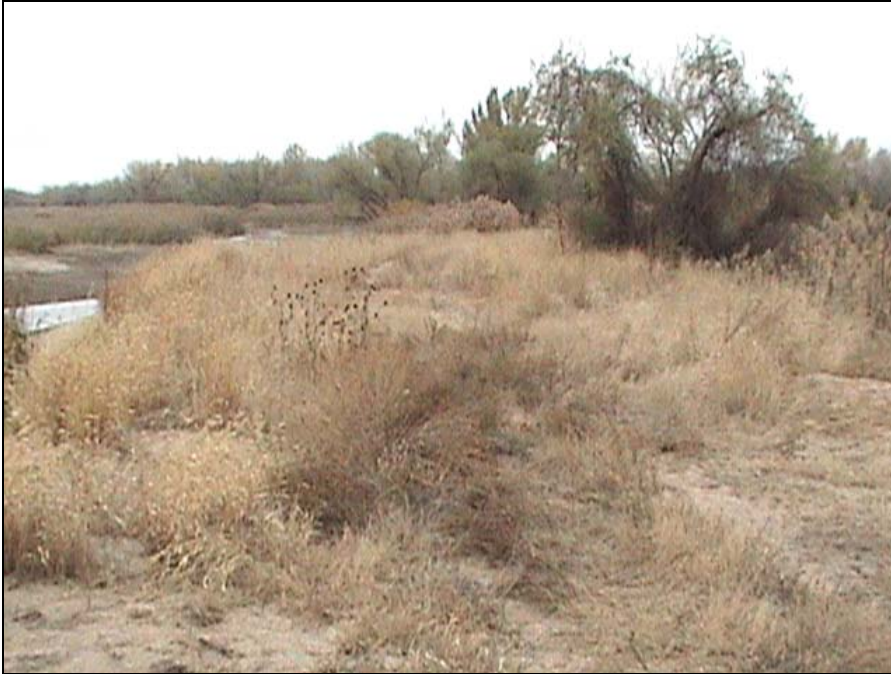
- Representative Larry Gill
- Priority dates 10-22-1894 (total 23 cfs)
- Located on southern channel below Platte River Sand Dam
- One sand dam is needed to force water to diversion
 - Sand dam last breached in 1997-1998 (approximately 15,000 cfs) (Figure 19)
- Bypassed water provides flows to Orchard-Alfalfa Canal

Figure 19. Sand dam for the 6-mile Canal.

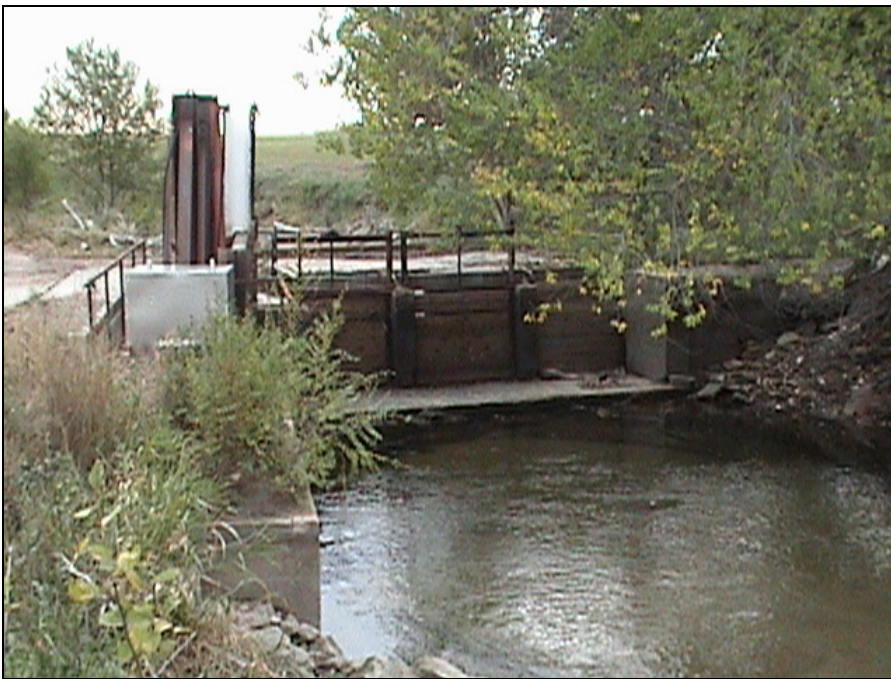
- Representative – Curtis Sargent (Operator)
- Also known as South Side Irrigation District and Jerk Water Irrigation District
- Receives water through Gothenburg Canal bypass
- Located on southern channel with 2 sand dams needed to force water to diversion
 - The first sand dam was breached in 1997-1998 (approximately 15,000 cfs)
 - Decreasing availability of sand in channel increases difficulty in rebuilding dams

- Diversion has been susceptible to damage due to prior high flow events
 - Channel degradation has resulted in scour below the diversion's apron

Figure 20. Main channel diversion for the Orchard-Alfalfa Canal.

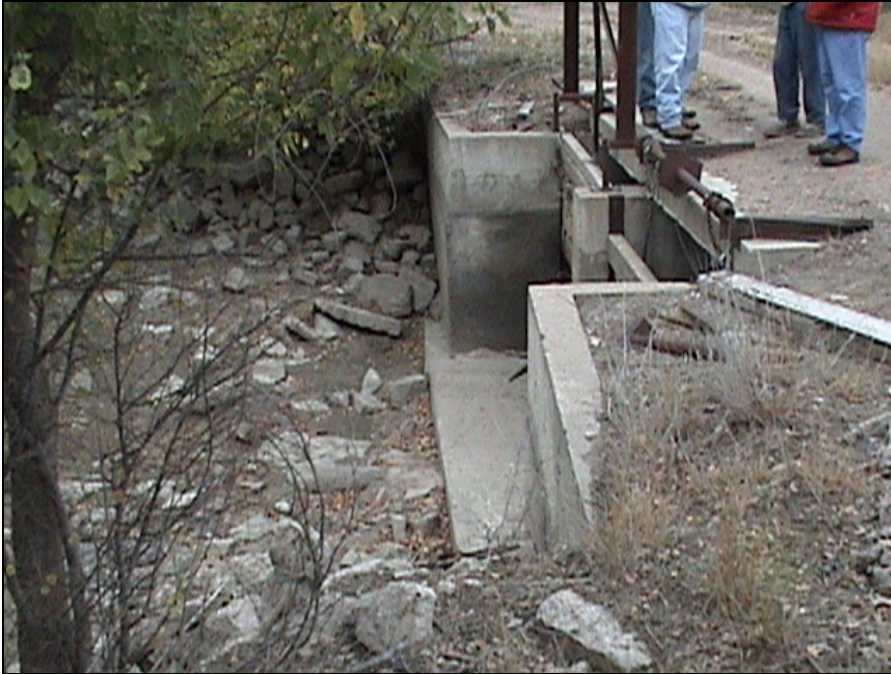
Figure 21. Gates for the Orchard-Alfalfa Canal.

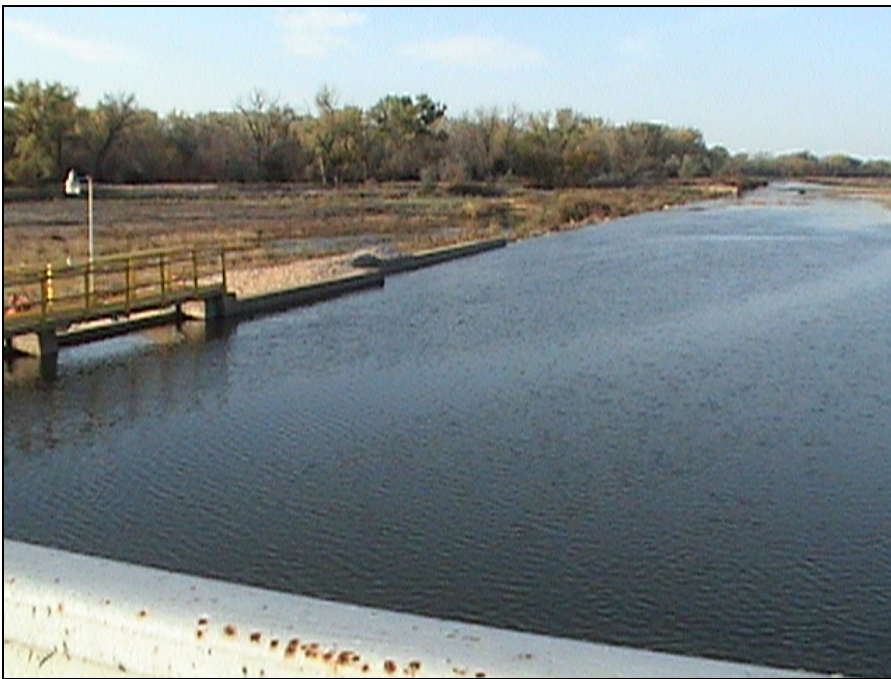
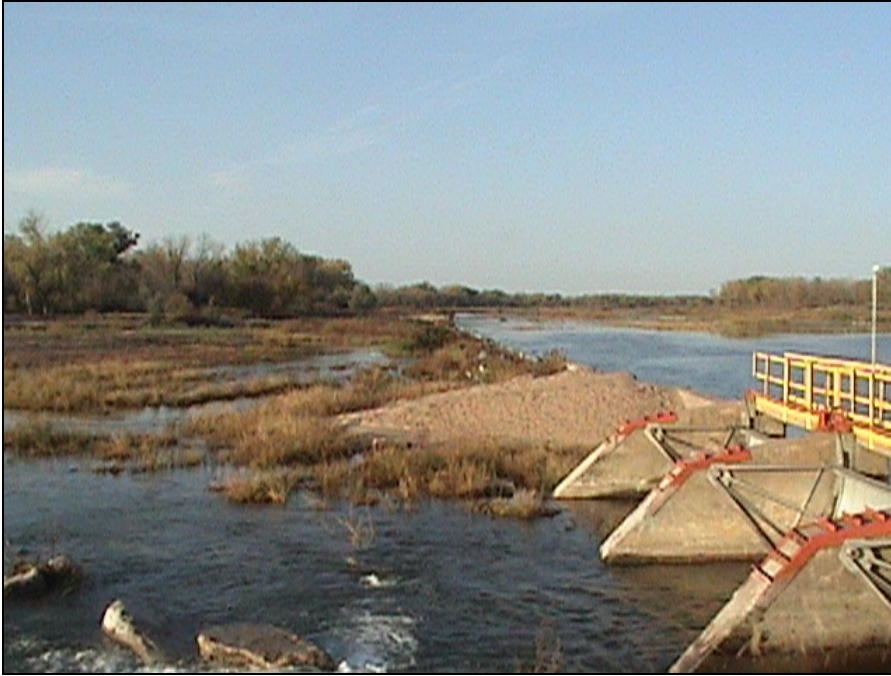
- Representatives Dave Webster and John Shadle
- Priority dates 9-10-1882 to 8-24-1987 (total 405 cfs)
- Solidly built mainstem diversion receives water primarily from the J-2 return
 - Also receives water from Platte River generally after the irrigation season (Nearest gage at Overton)
- Diverting approximately 280 cfs (as of October 5, 2006)
- Annual diversions usually occur up to November

Figure 22. Kearney Canal diversion dam

Figure 23. Kearney Canal diversion dam
